QA-55A
Ripley Slave Quarter
Church Hill
Private

INVENTORY FORM FOR STATE HISTORIC SITES SURVEY

Slave quarter at Ripley

RIPLEY SLAVE QUARTER
CHURCH HILL, MARYLAND

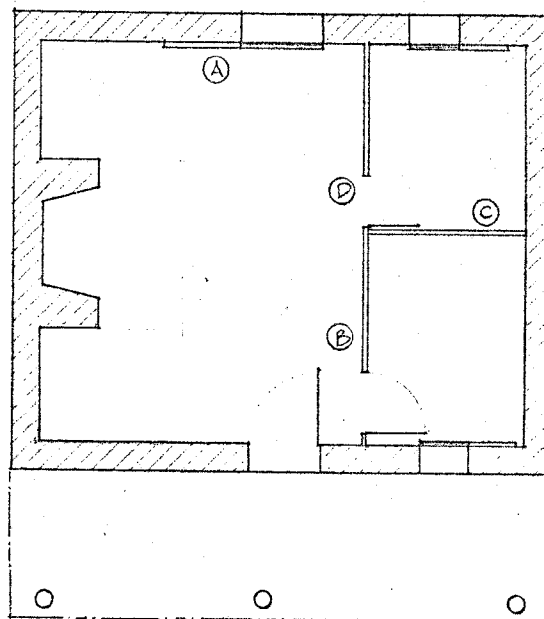
- A HORIZONTAL SLIDING SASH WINDOWS
- B BEADED BOARD PARTITION APPEARS TO BE ORIGINAL
- C PAIN BOARD PARTITION APPEARS TO BE LATER
- D SMALL DOOR MAY BE LATER

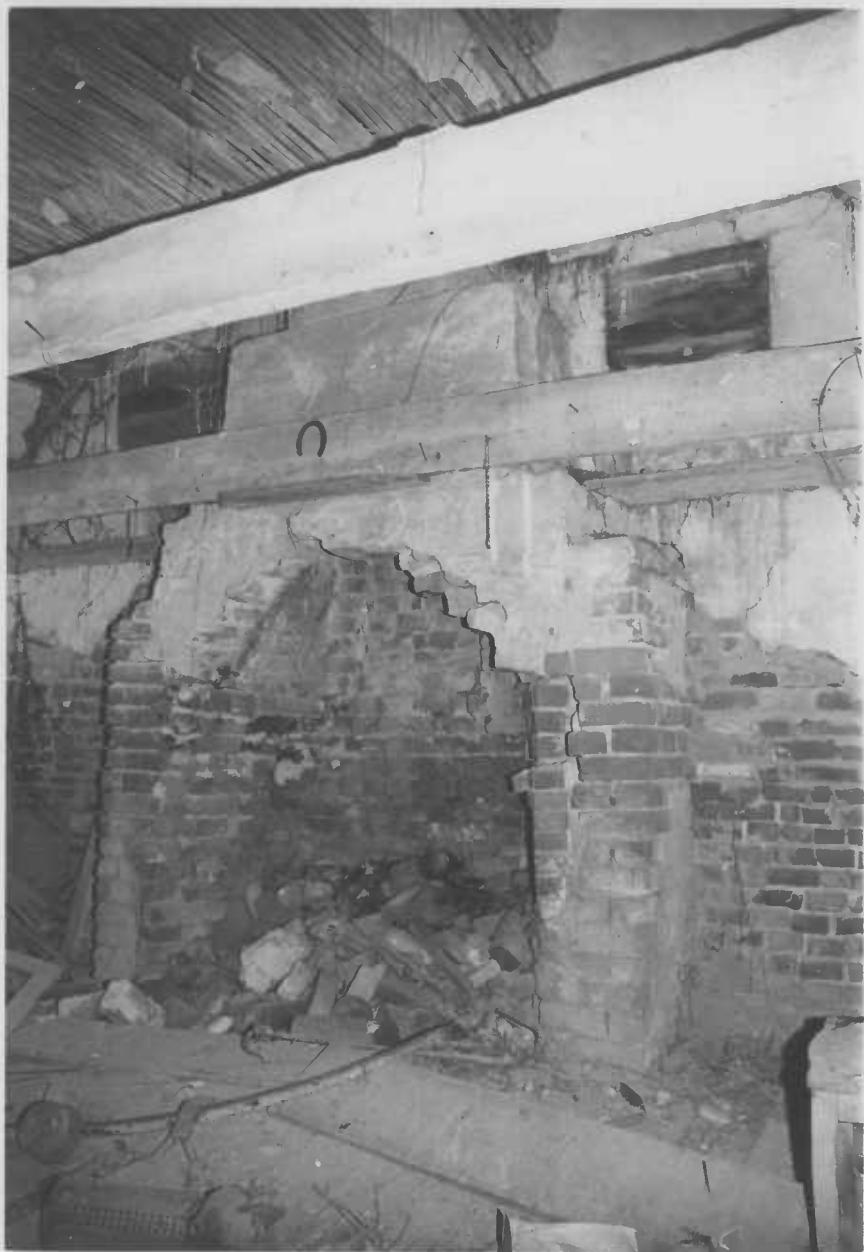
QA-55A Ryley Slave Quarter

The chimney has partially collapsed, but the curved iron lintel support remains among the debris, as does a very fine wrought iron trammel bar.

Cooking fireplace in slave quarter
Church Hill
